**STATE OF HAWAII**  
**DEPARTMENT OF LAND AND NATURAL RESOURCES**  
**OFFICE OF CONSERVATION AND COASTAL LANDS**  
Honolulu, Hawaii

**REGARDING:** Enforcement File No. MA-08-30  
Regarding Unauthorized Seawall Improvements Located Makai of  
Shoreline in the Vicinity of Subject Parcel (2) 4-4-001:042

**BY:** Hale Kai AOA Condominiums, 3695 Lower Honoapiilani Road,  
Lahaina, Island of Maui - Owner of Subject Parcel (2) 4-4-001:042

**COASTAL ENGINEERING INVESTIGATION AT  
HALE KAI CONDOMINIUM, LAHAINA, MAUI**

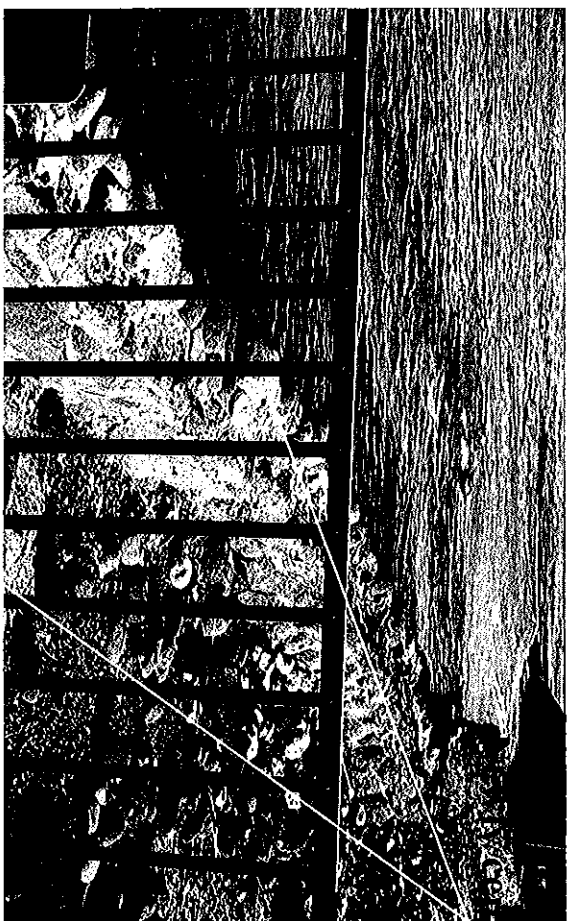
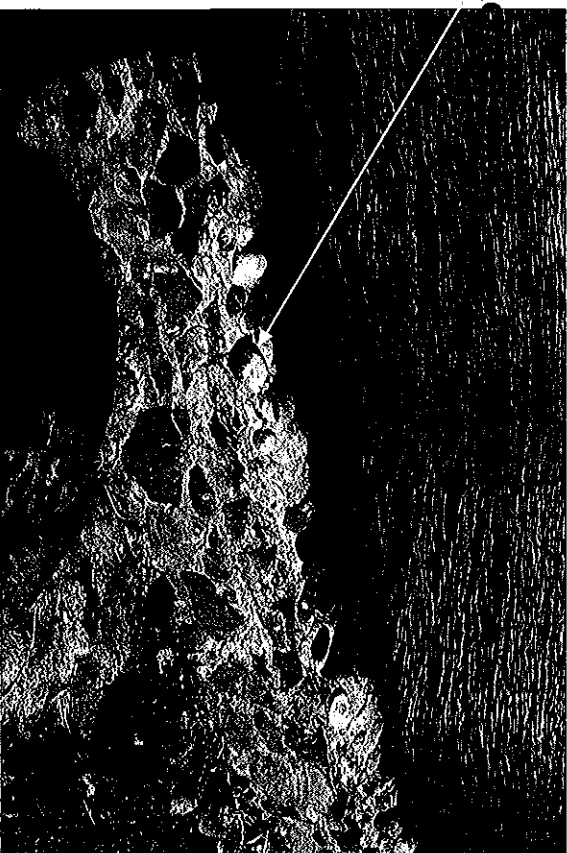
Hale Kai, TMK: (2) 4-4-001:042

Photos depict the seawall fronting the Hale Kai complex. It appears that an additional layer of rocks has been cemented onto the top of the wall in an attempt to elevate the wall's current height.

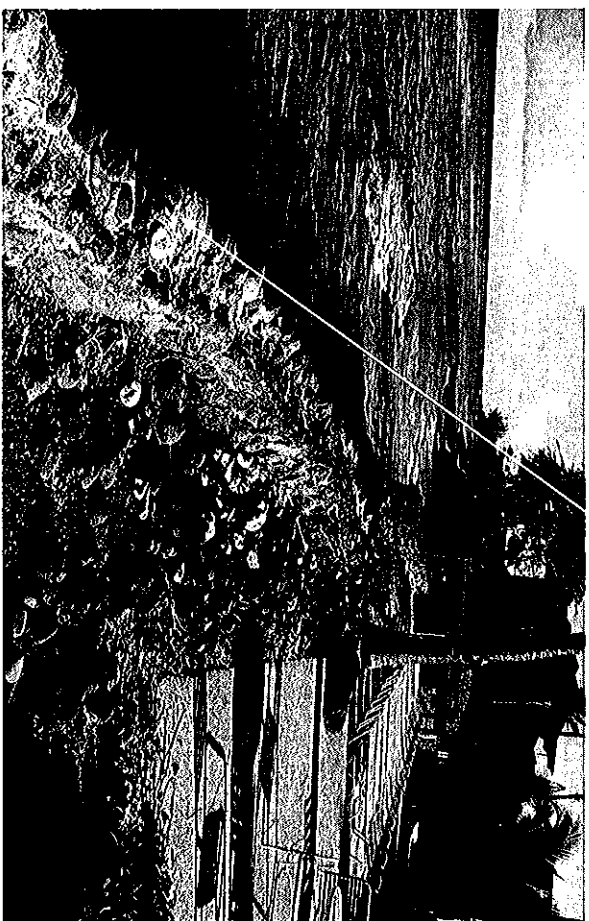
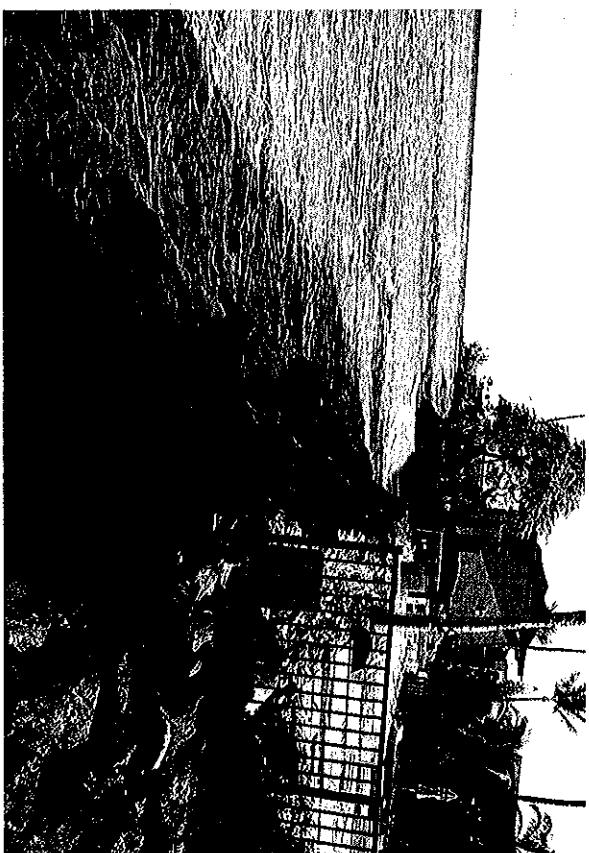
View of wall from the south facing in the northerly direction.

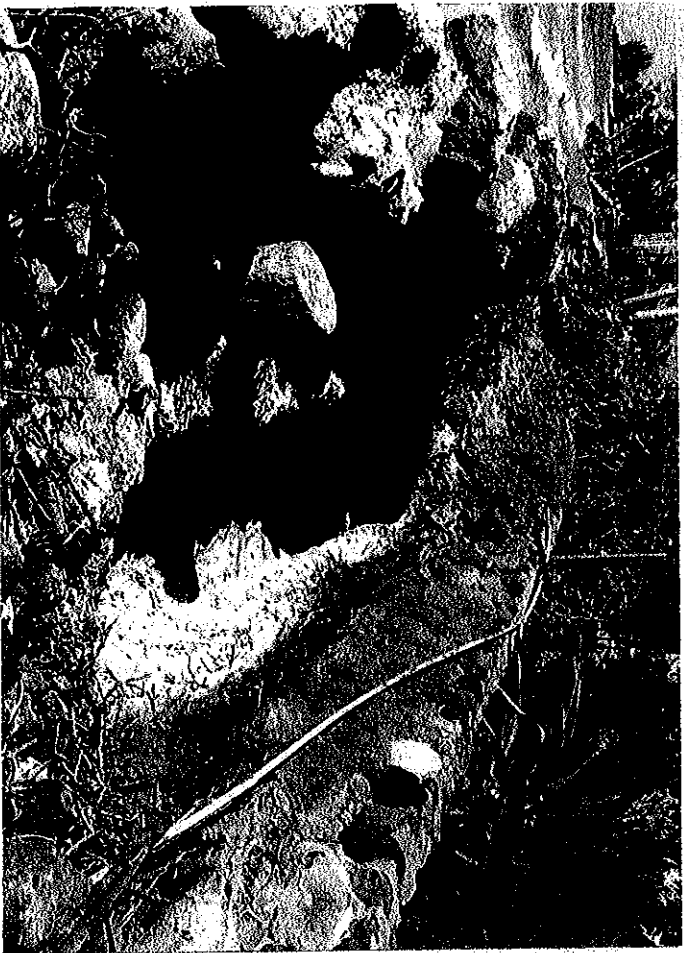
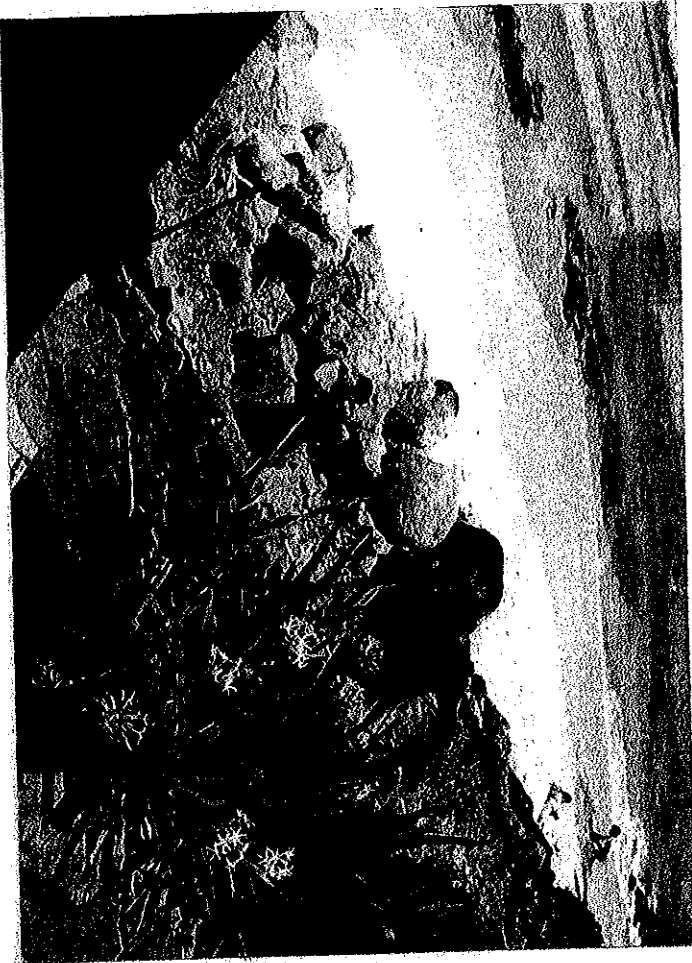
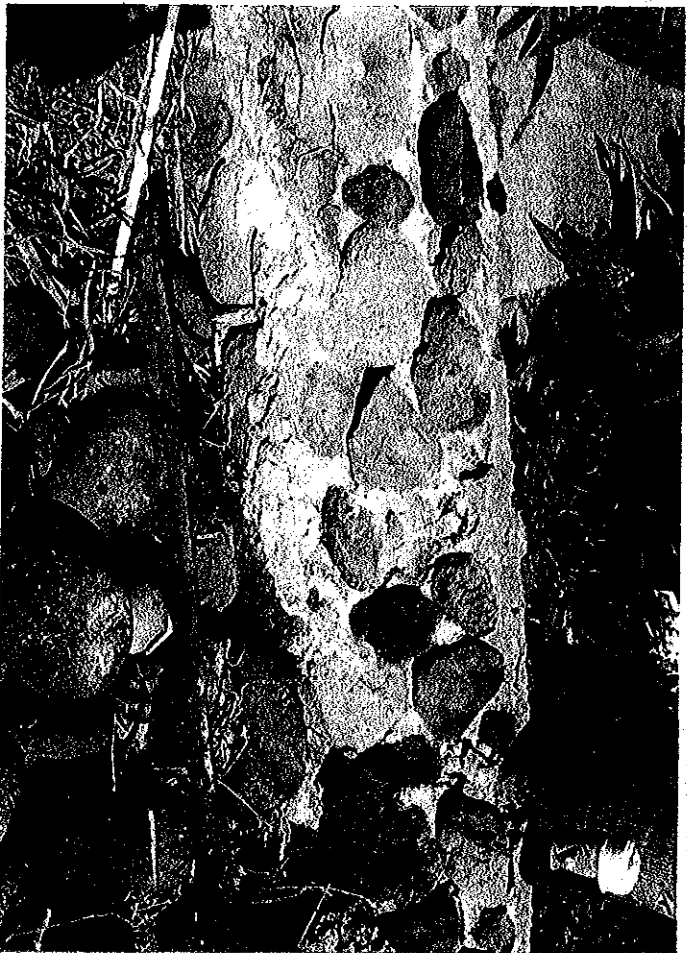
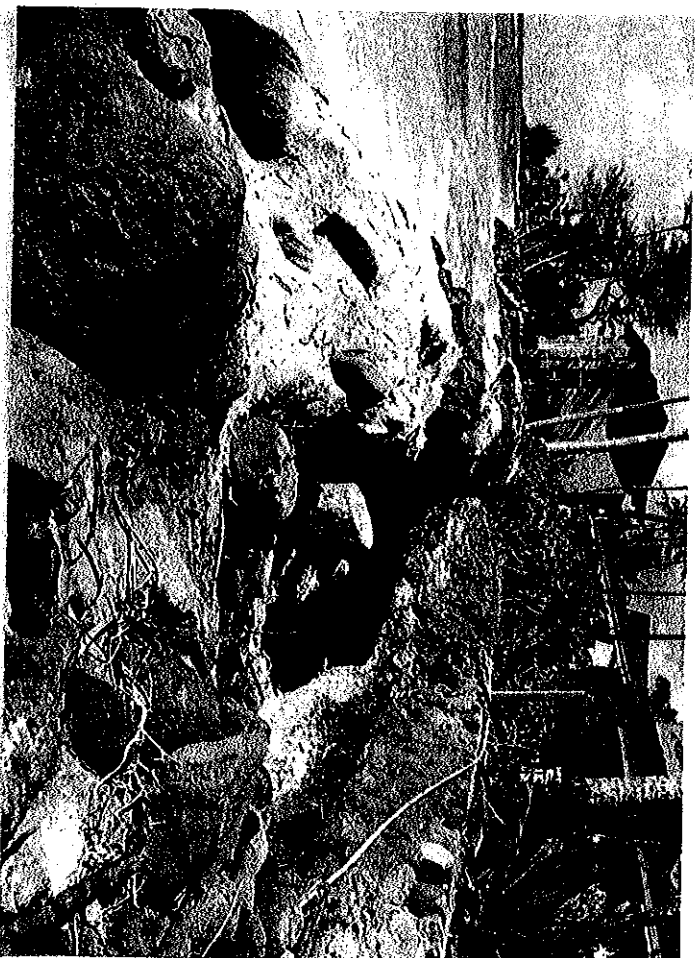
4/28/98 DIGGING OF TRENCH ON THE OCEAN SIDE  
OF WALL. 3 MEN 4 FT 25

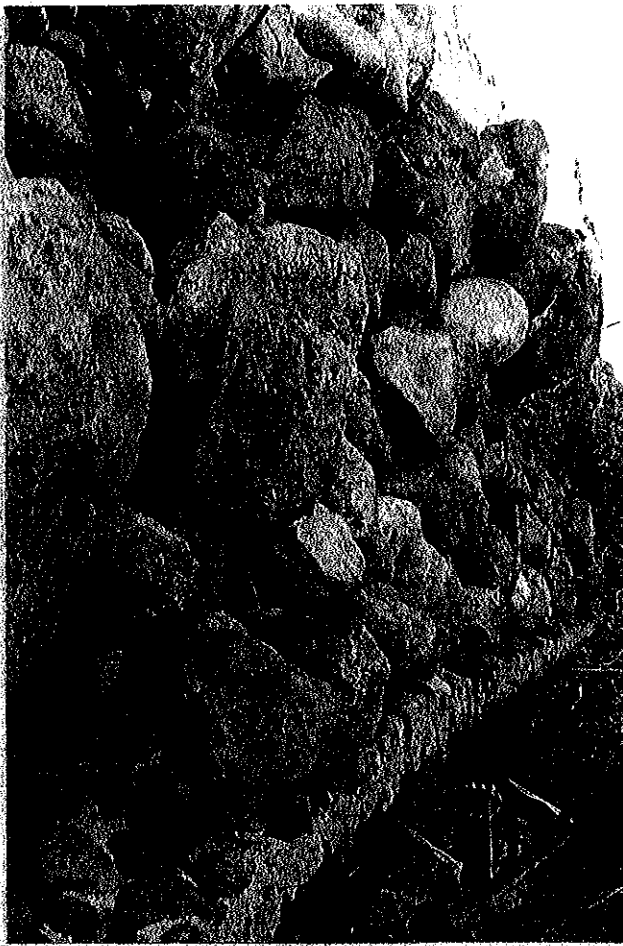
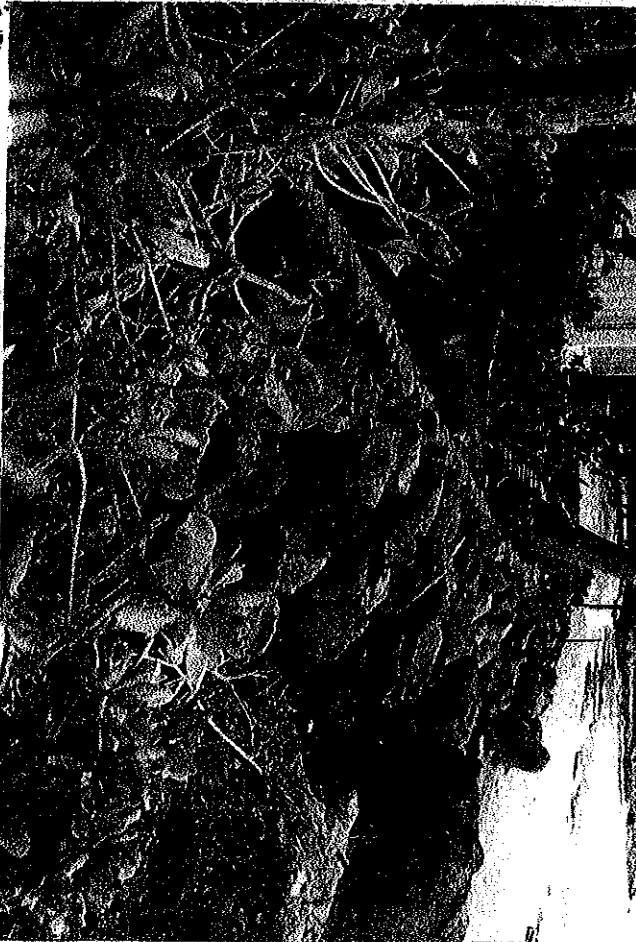
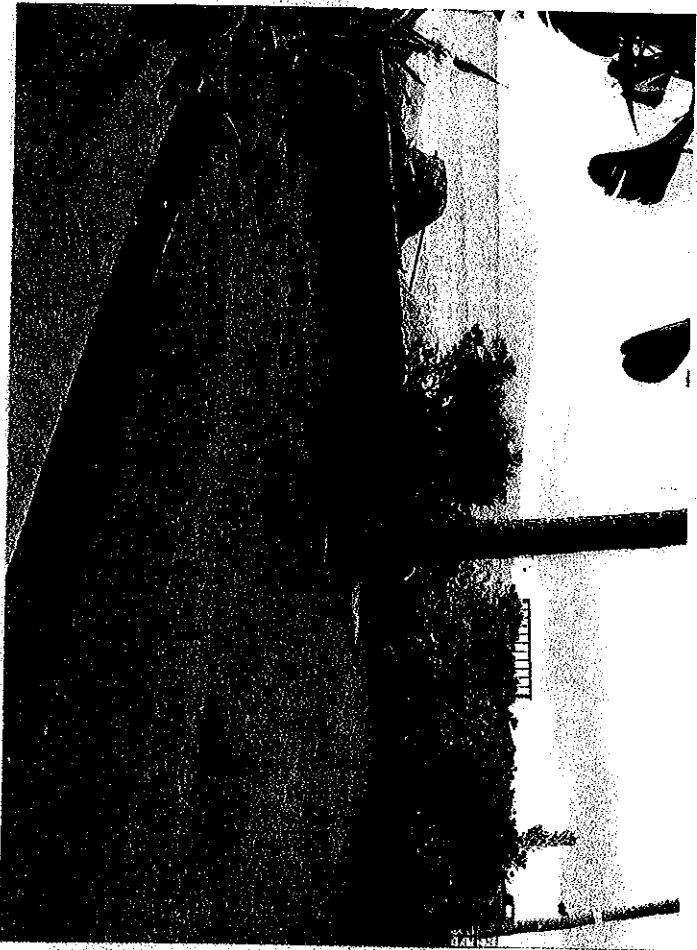
5/7/98 AFTER LARGE ROCKS WERE PLACED  
END OF MAJOR WORK ON SEAWALL REPAIR

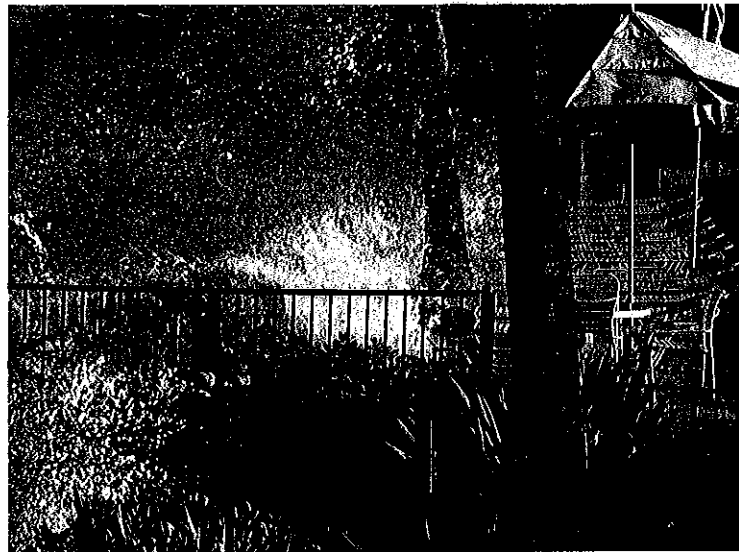
11/15/07.2.JPG

SPLASHING  
OVER WALL

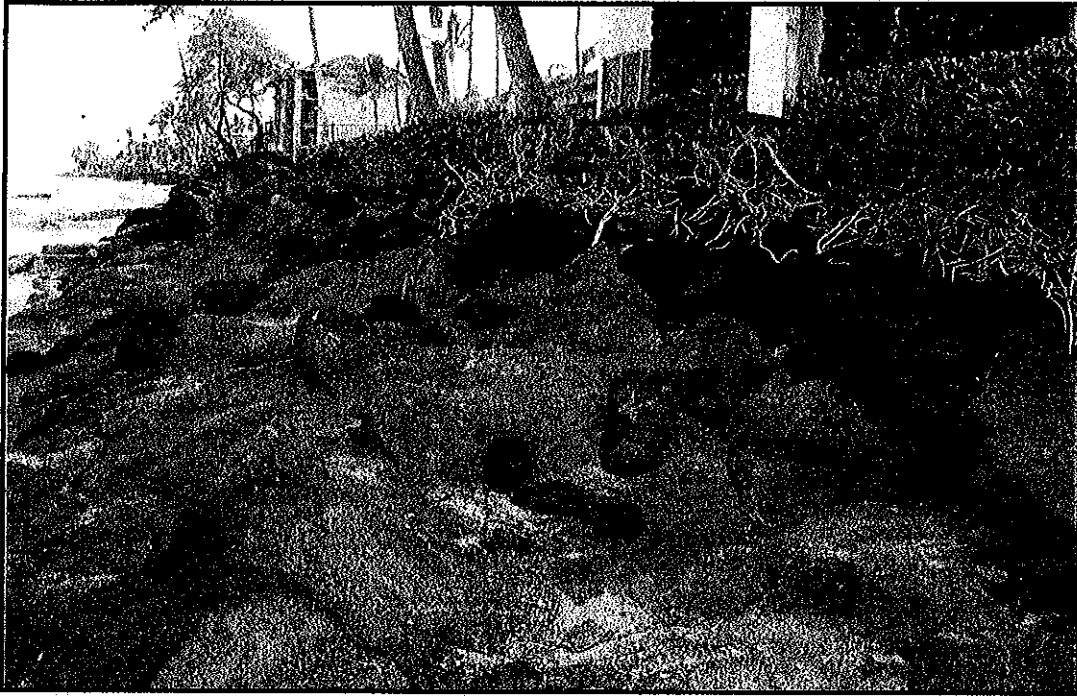
**Figure 1. Hale Kai grouted rock seawall**

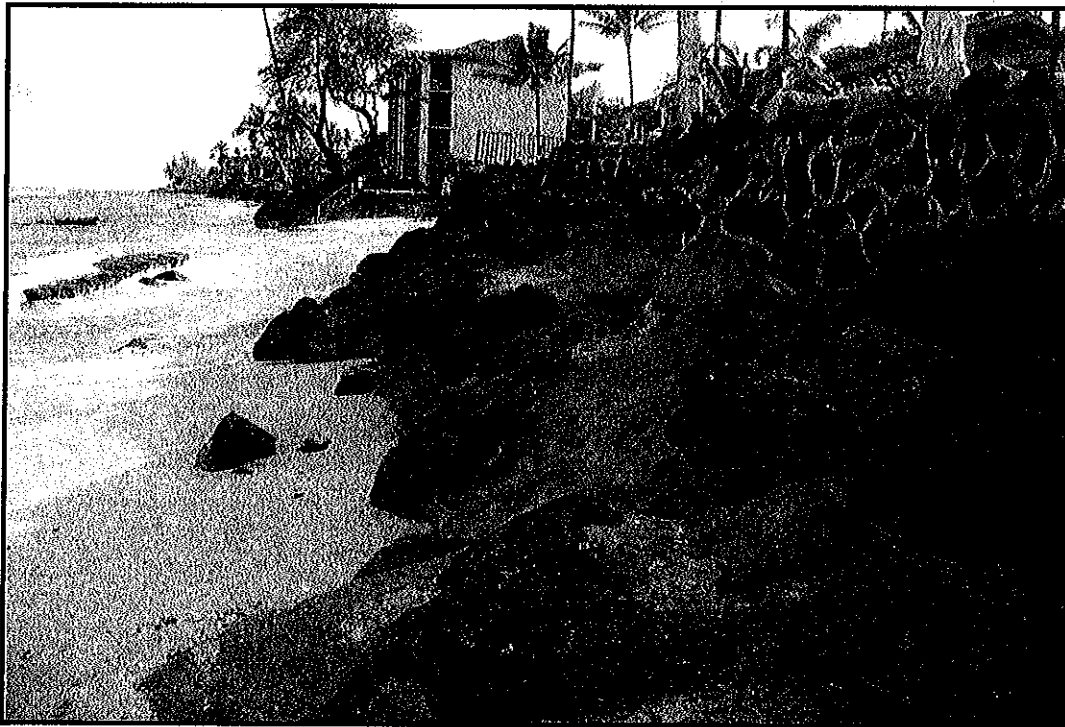
A coastal engineer from SEI visited the site on April 9, 2007. The beach fronting the sand was in an accreted state, with sand burying the toe of the seawall around the exposed perimeter of the property (Figure 2). Because the toe was buried in sand undermining of the seawall was not observed except in a few locations where fractures and holes existed in the grouted surface of the wall (Figure 3). Nevertheless, given the nature of the construction, and the holes that were observed, we concur with HLA that undermining and consequent hydraulic sluicing under and behind the seawall has been causing the problems observed in the HLA reports.

**Figure 2. Hale Kai seawall showing transition in structure slope**

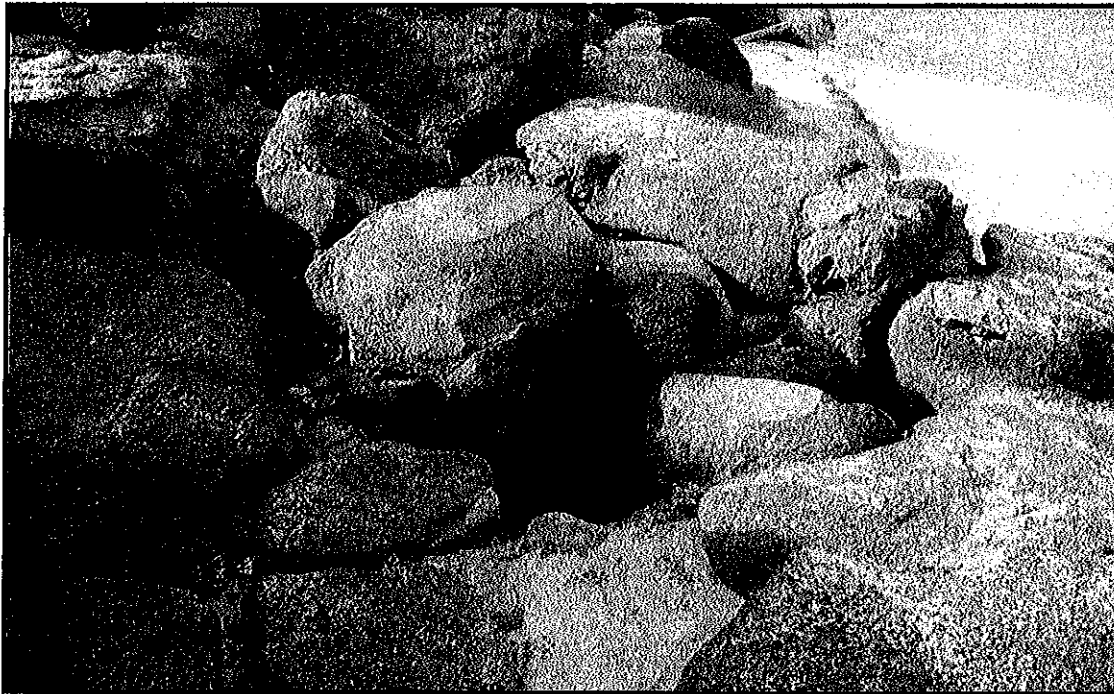
The explanation given by HLA for the erosion behind the wall is undermining of the seawall and consequent hydraulic action on the substrate. Geotechnical investigation conducted in 1985 as part of the site investigations for design of repairs found that the soil conditions consist of fine to medium grained sand resting on a layer of weathered coral at about -2 ft MSL. The design reports are consistent in their assessment that settling of the seawall and the new filter wall may occur down to the -2 ft elevation where the more firm layer of weathered coral exists.

**Figure 3. Cracks, holes, and undermining in the seawall**

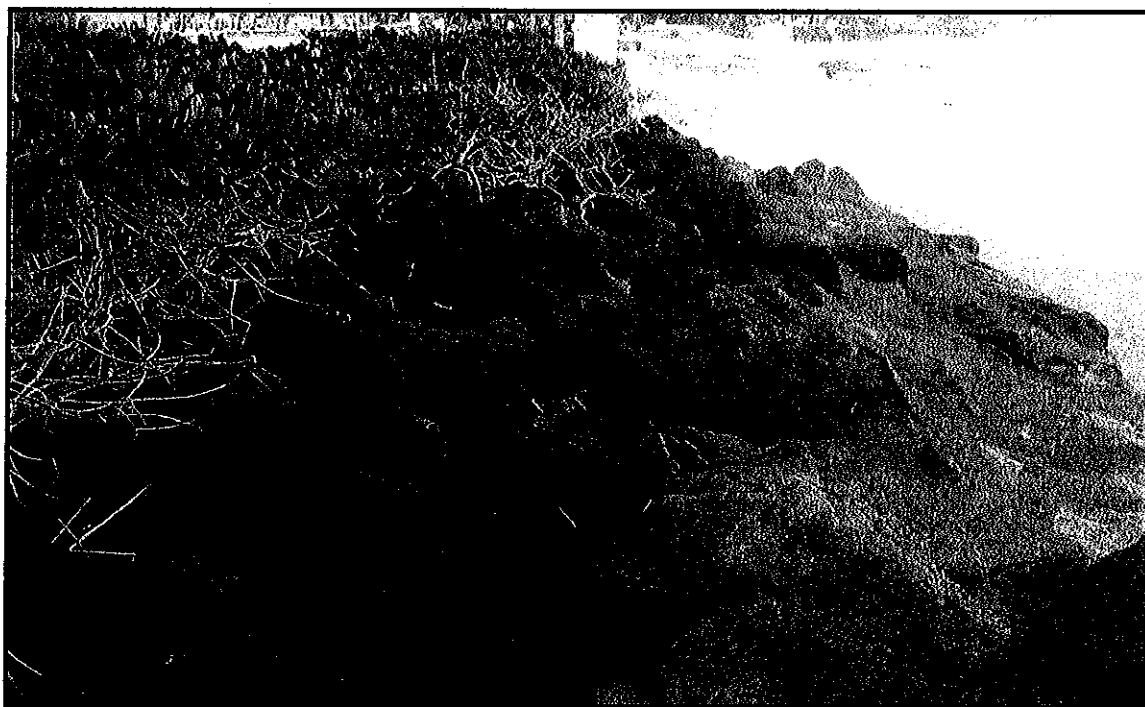
**Figure 4. Third phase construction area – foreground boulders have settled.**

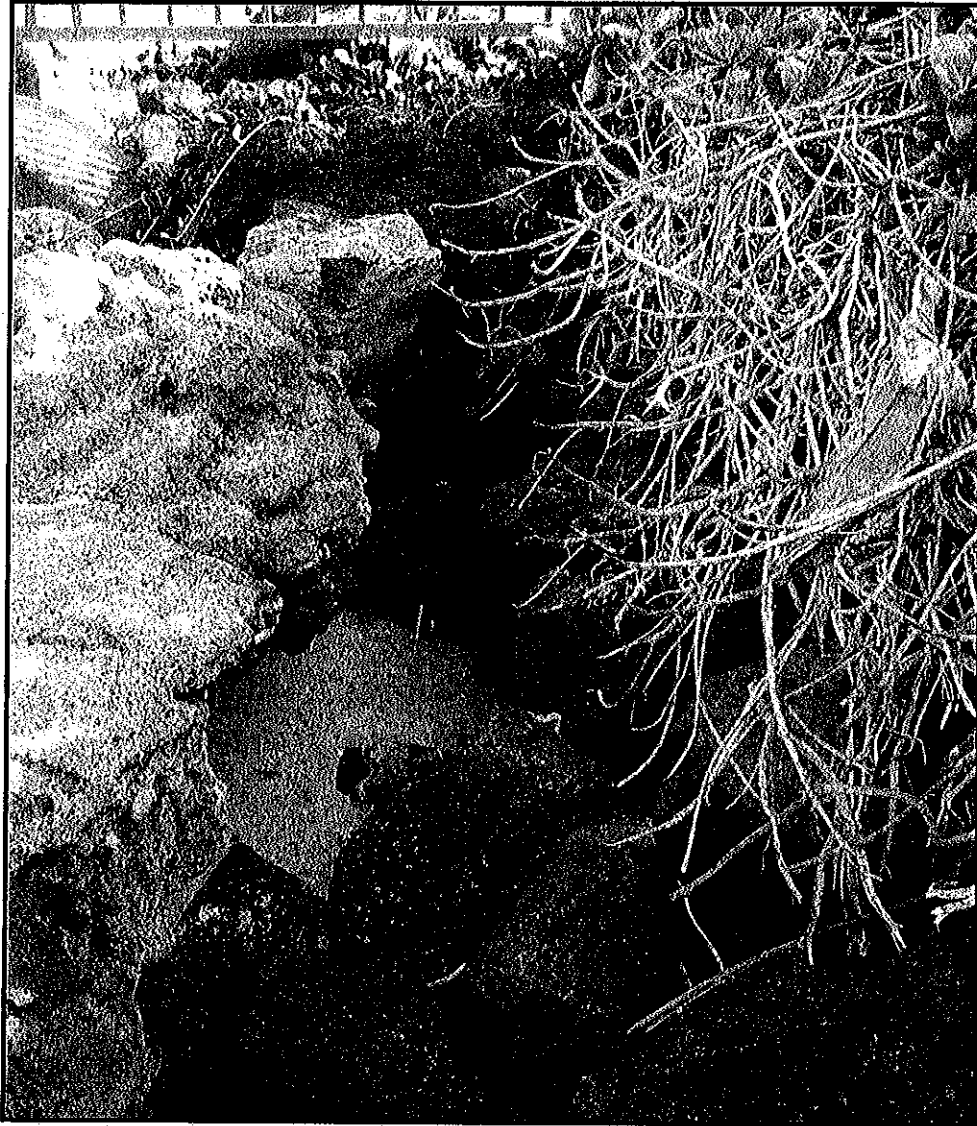
As a result of the consultant's investigation and recommendations, numerous repairs have been effected behind the seawall. Of particular note, and as described in Table 1, HLA recommended the construction of a gravel filter wall behind the seawall. The purpose of the gravel filter was to prevent the fine sand soil from being eroded and washed out. According to the present Board President, the construction behind the seawall occurred in three phases. The first phase was placement of the gravel filter wall in front of the swimming pool at the north end of the property. The second phase was placement at the south end of the property, and the third phase was an approximate 50-ft section that connected the two. The last phase was apparently not constructed according to design, and rock boulders were placed without gravel or filter cloth. Portions of this 50-ft section of settled such that there are now void spaces behind the seawall.

**Figure 5. Third phase construction area showing undermining and settling of boulders behind the seawall and undermining of the pool deck slab. Sand deposition is caused by wave overtopping.**

Some areas of the seawall appear to be substantially unsupported due to erosion behind the wall. This may pose an existing hazard or a hazard during construction of repairs. We recommend consultation with a structural engineer to evaluate these hazards and to recommend a shoring design if necessary.

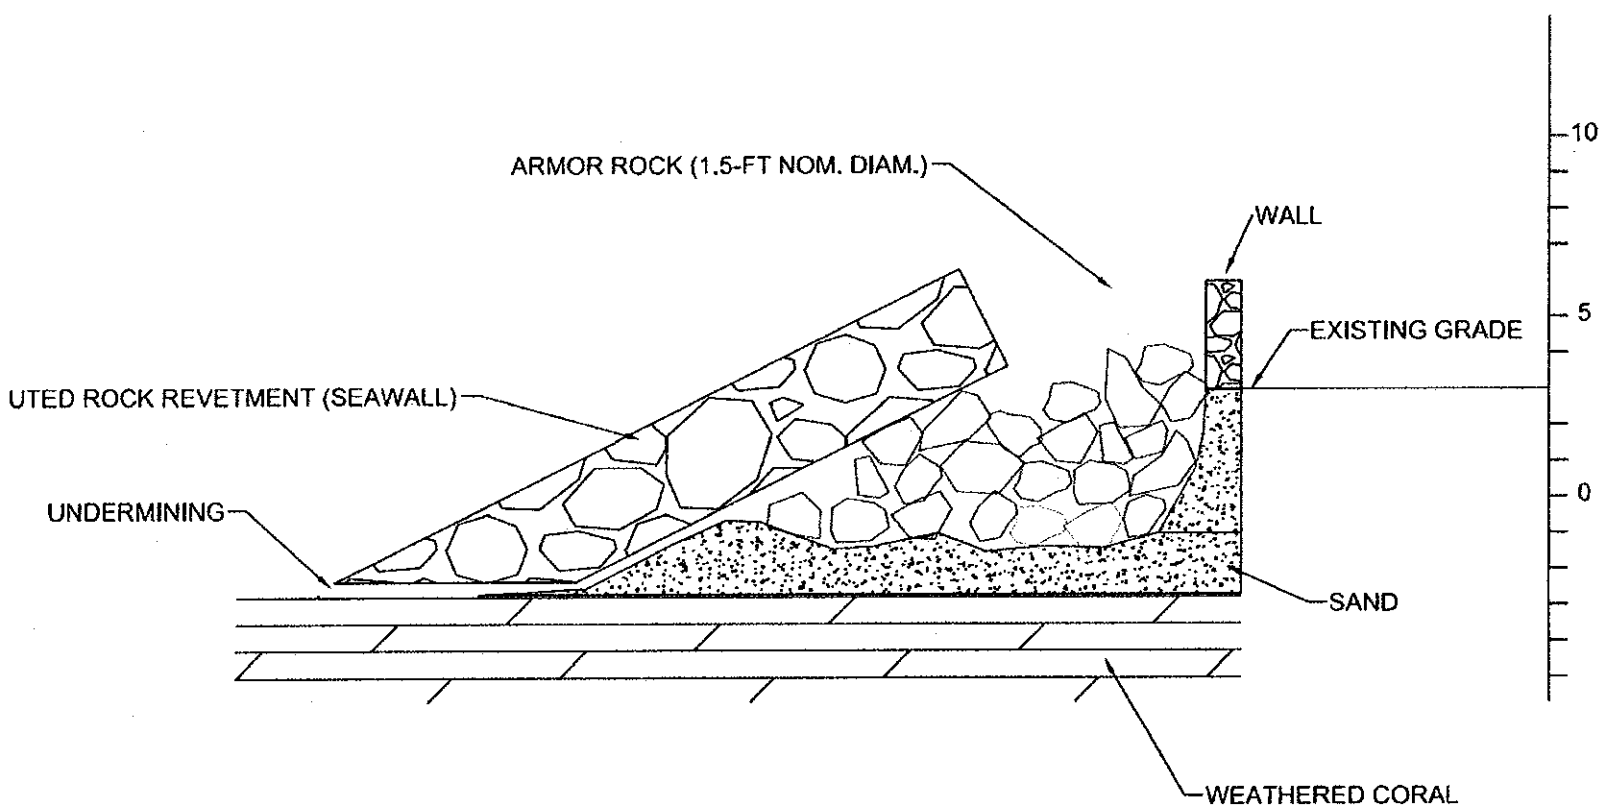
## HALE KAI SEAWALL: EXISTING CONDITIONS

Existing conditions are shown schematically in Figure 6.

**Figure 6. Existing seawall construction at location of phase 3 repairs**

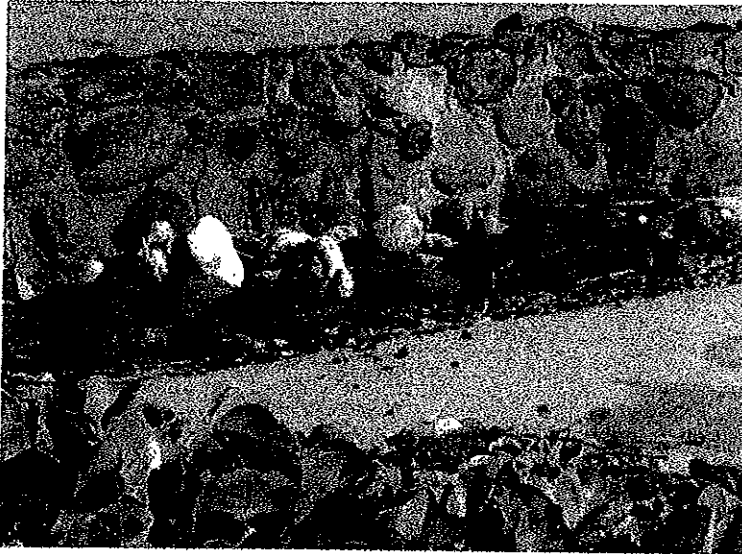
PROPERTY INSPECTION  
REPORT FROM  
9/6/07 NAI'A

John Male has been placing beach rock at the sea wall to address erosion of sand into the pool and deck area.

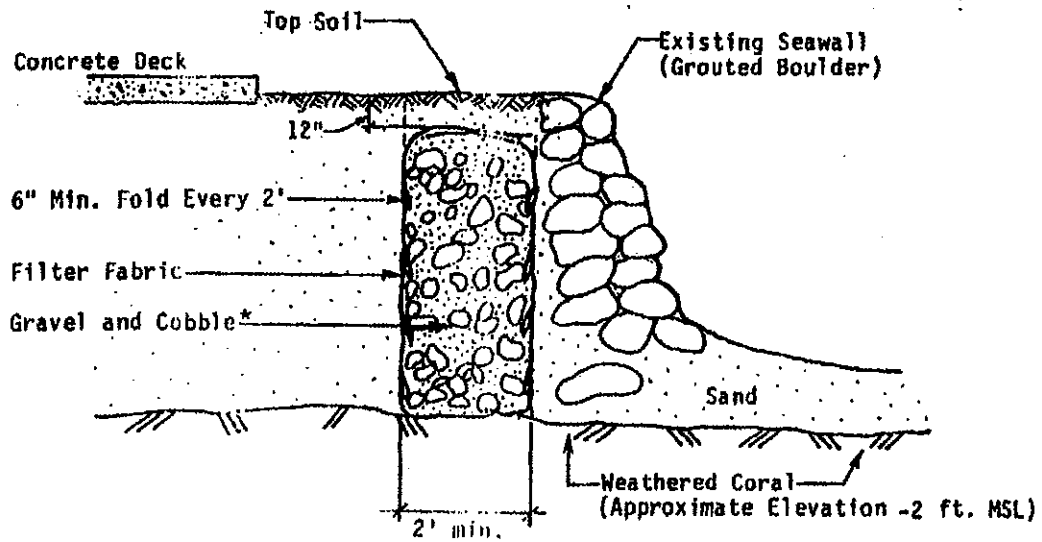
1. Dig a trench approximately 50' long by 8' deep by 2' wide immediately behind existing rip-rap bolder seawall. Smaller rock and stones behind existing seawall must be removed so that the excavated trench abuts the existing large bolder seawall. Excavated clean sand may be disposed upon the beach; excavated rock and rubble may be re-used as part of the finished gravel-filled trench.
2. Line excavated trench with overlapping filter fabric, as shown in attached sketch.
3. Fill excavated trench with excavated smaller rock and rubble. Supply gravel to fill the remainder of trench.
4. Powered excavation equipment must be capable of gaining access between pool and park building without causing excess damage to existing landscaping.
5. Work to be completed within 3 days of start. Time of start to be in late April or May, with a weather prediction calling for low surf and low tides (?).

\* **NOTE:** The gravel and cobble should range in size from  $\frac{1}{4}$  to 12 inches with 85 percent or more in sizes smaller than 6 inches, and with 3 percent or less passing the No. 200 sieve.
